Case No. 4:15-cv-00250-TUC-DCB

**DECLARATION OF ELDON VAIL
IN SUPPORT OF PLAINTIFFS'
MOTION FOR PRELIMINARY
INJUNCTION**

2 6. I have been asked by Plaintiffs' counsel to offer my opinions regarding the
3 conditions of confinement in Tucson Sector Border Patrol Station Hold Rooms ("Hold
4 Rooms").

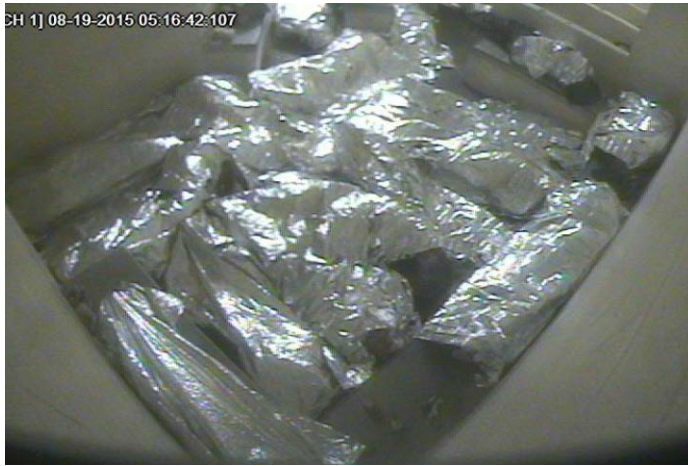
(Ex. 188).

16 32. Surveillance video from Tucson Station reveals that Defendants routinely
17 pack so many individuals into holding cells that detainees are commonly forced to lie
18 down on the concrete floors beneath the toilet stalls. Others are crammed so tightly, they
19 look like sardines in a can, with no room to move in any direction without rolling over
20 someone else:

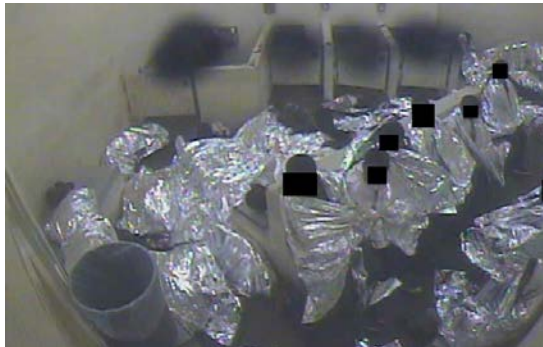
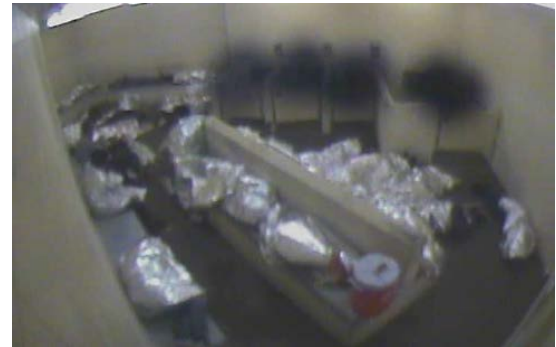
52. Although CBP apparently has no policies with respect to how often the Hold Rooms must be cleaned, surveillance footage from Casa Grande station shows hold rooms being cleaned once per 48 hours, if that. (Coles Decl. ¶ 41.) There are no cleaning supplies in the hold rooms and, according to detainees, the rooms often lacked a trash can. (ECF No. 2-1, Ex. 8 ¶ 11; *id.*, Ex. 16 ¶ 25; *id.*, Ex. 43 ¶ 15.) This means, effectively, that the Hold Rooms are hardly ever clean and that the areas around the toilets are generally dirty. (ECF No. 2-1, Ex. 8 ¶ 11 (diapers, toilet paper and other trash was strewn around the bathroom area); ECF No. 2-3, Ex. 35 ¶ 24 (1 toilet backed up and smelled terrible).) Unfortunately, this fact does not stop the overcrowding of the cells which makes it necessary for some detainees to lie down very close to those toilets in order to find a place to sleep:

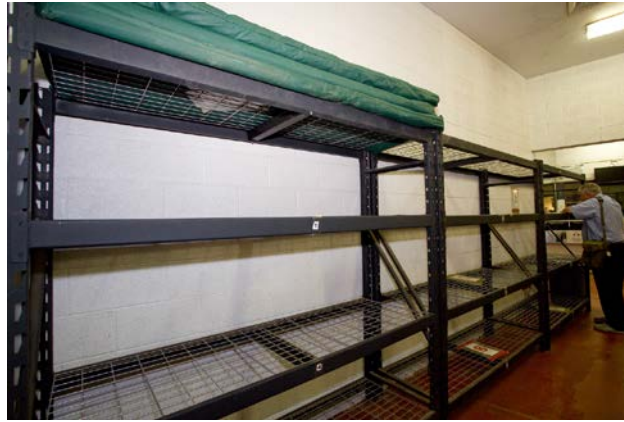
(Ex. 3.)

25 57. During my inspection of Casa Grande station, there were only three mats in
26 the entire facility:
27
28

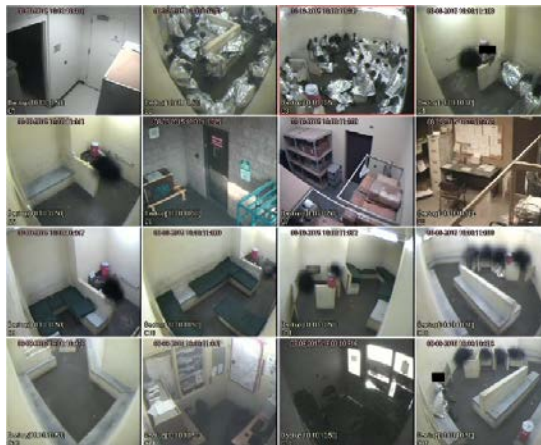
(Ex. 170; *see also* Ex. 147.)

59. Surveillance video from some of these stations often shows detainees lying on the concrete floors while, at the exact same moment in time in the same station, mats go unused in other unoccupied or less occupied cells:

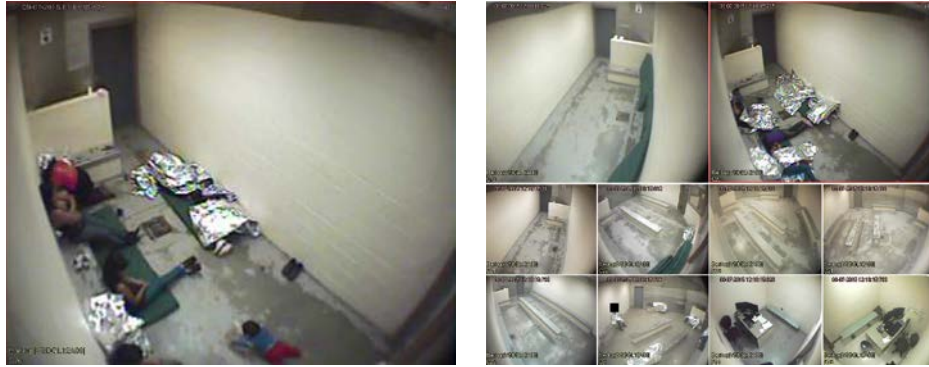
(Ex. 146, 147; *see also* Ex. 155.)

60. Surveillance video also shows families and children confined in cells with too few or no mats:

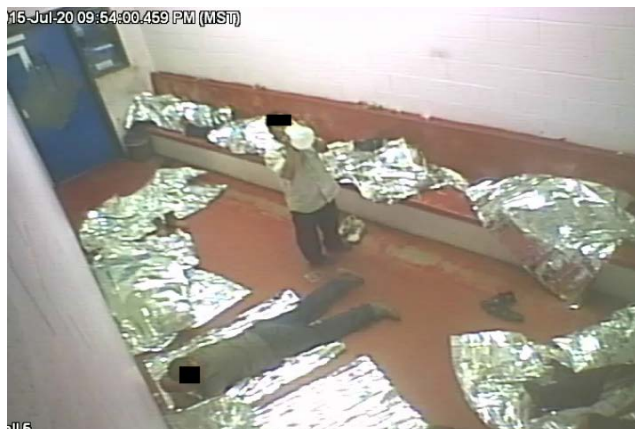
(Ex. 130; *see also* Exs. 125, 129, 130, 133, 141.)

18 81. This testimony is confirmed by surveillance video of the Casa Grande which
19 shows at least a dozen different detainees drinking from the same 1-gallon water jug over
20 the course of 5 days:

82. The jug was never replaced or cleaned, despite the cell being swept by maintenances crews on several occasions over the course of the 5 days it was used.

1 regularly and repaired quickly when they are broken. If they wish to continue using water
 2 jugs as part of their water delivery system, the regular cleaning and refilling of those jugs
 3 should be scheduled and logged. In no case should detainees be expected to share the
 4 same cups or drink from the same gallon jug as they present an obvious risk of the spread
 5 of contagious disease.

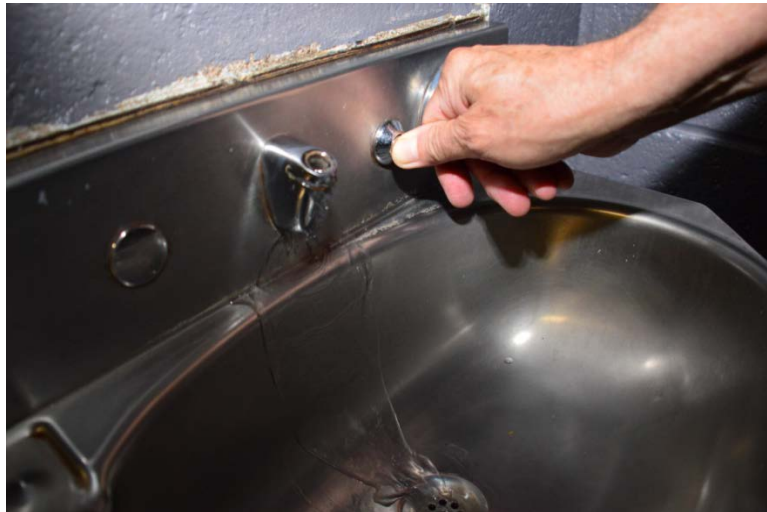
(Ex. 31.)

83. In hold rooms with “bubblers” to dispense drinking water, these were usually located just above or adjacent to the toilets, often as part of the same metal toilet/sink unit. During each of my inspections of the four stations, I observed numerous bubblers that did not work or had extremely low water pressure. One example of a malfunctioning bubbler is shown in the picture below:

84. In general, I believe that the problem with the bubblers is the same as with the toilets—they are subject to overuse as there are not enough of them for the numbers of detainees placed in the holding cells⁶ and they are not regularly inspected and repaired.
